**ICOLD & APG Symposium  
on  
Sustainable Development of Dams & River Basins**

**INNOVATIVE METHODOLOGY TO CONTROL  
SEEPAGE OF PATHAZHAKKUNDU  
EARTHEN DAM IN KERALA, INDIA**

**DR. P.T.SANTHOSH KUMAR**

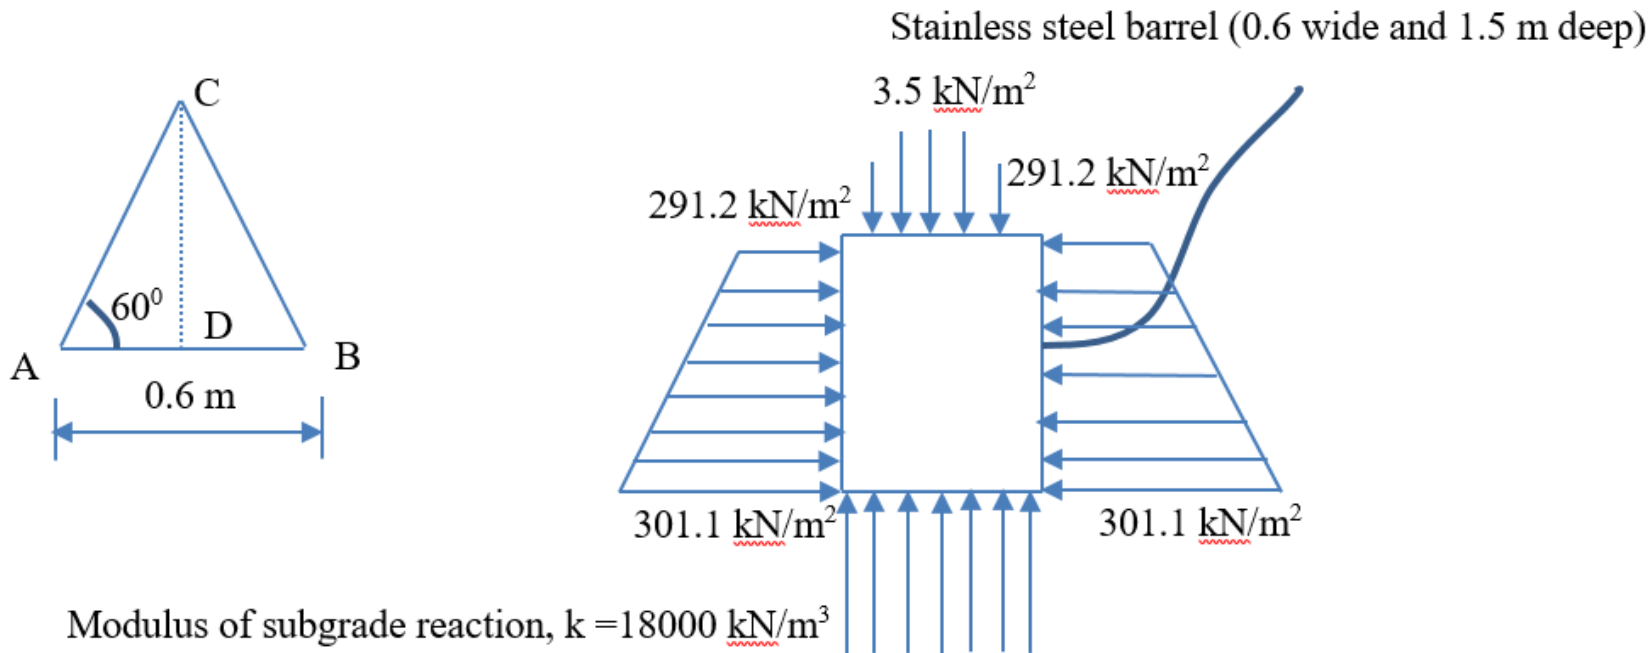
**FIG 1- STAINLESS STEEL BARREL WITH FORCES**

- Structural component- Structural component is checked by modelling in STAADPRO considering it as a free body with the associated forces. For this purpose, the section with maximum overburden was chosen, which is  $131.06 - (115 + 1.5) = 14.56$  m, with the length of 6 m, which is the length of a unit of the steel barrel.

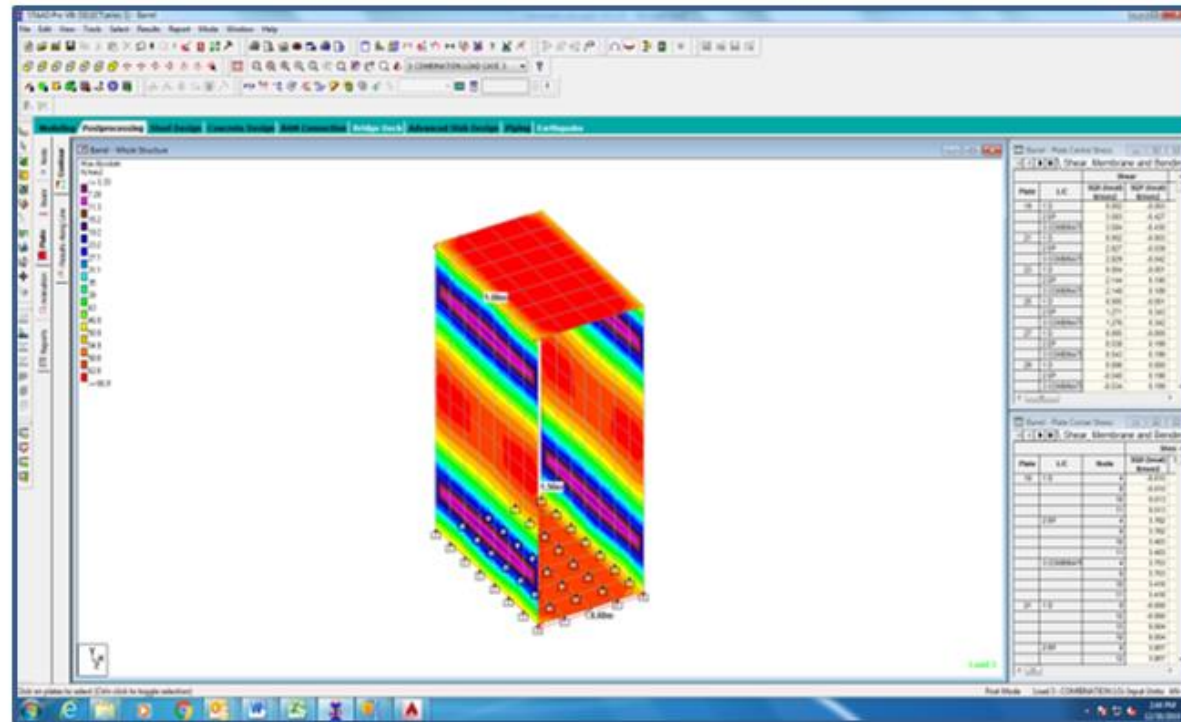
**FIG 4- STRESS CONTOUR IN THE MODEL SHOWING WITHIN LIMITS**
