**ICOLD & APG Symposium
on
Sustainable Development of Dams & River Basins**

**EVOLVING REPAIR METHODOLOGIES FOR SPILLWAYS &
STILLING BASIN
IN HIMALAYAN REGION**

NHPC LTD, FARIDABAD, HARYANA, INDIA

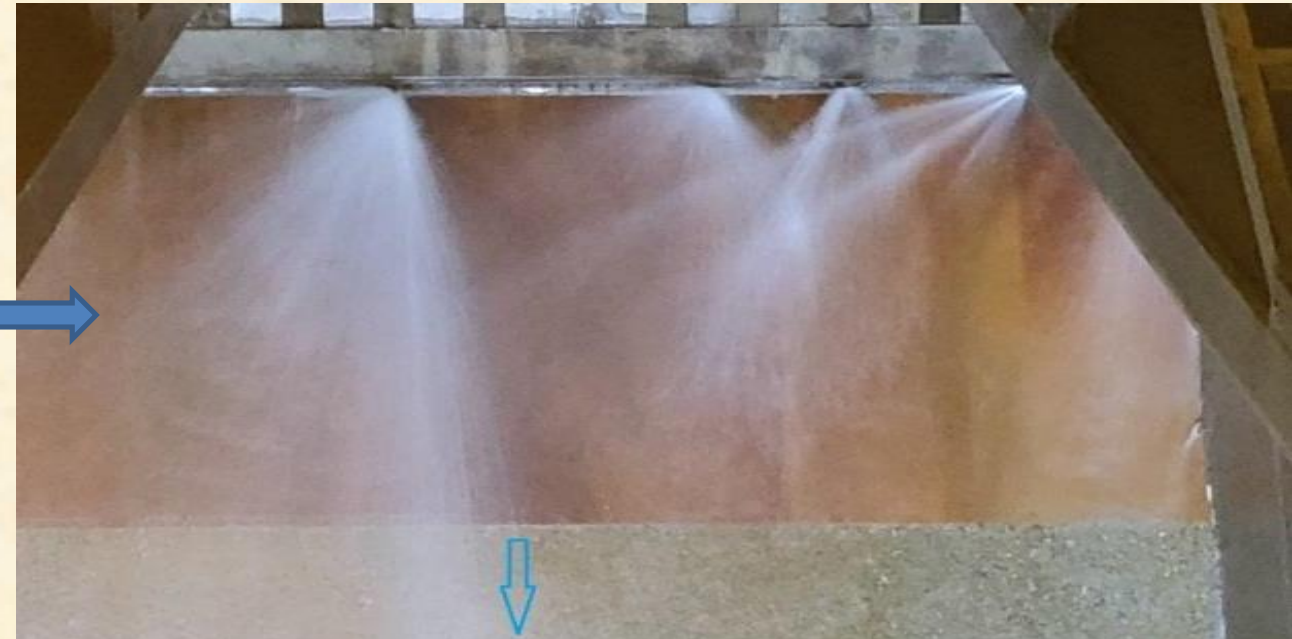
Erosion in Glacis after one year operation, before installation of steel liners

Erosion of Glacis after two years of operations with Steel Liner installed

- The resistance of steel plates against cavitation, abrasion and impact loads is well established.
- Thick steel plates can resist impact load generated by big boulders during high flood conditions.
- Anchoring of new plates with existing concrete surface was being considered difficult because of vibrations leading to fracturing and eventual failure.
- At Dhauliganga spillway with severe erosion condition 32mm thick steel liner was installed with countersunk bolt @ 250mm c/c.
- The top of the countersunk bolt was placed 10mm below the finished surface which was flushed with compatible welding material after installation.
- At the end of steel plates, steel cutoff was also provided.
- The performance has been found satisfactory inspite of heavy boulder rolling at high velocities.
